TC Rear Axle Tower Repair

(And how to keep it from failing in the first place)

Steve Simmons
TC Motoring Guild
May, 2021

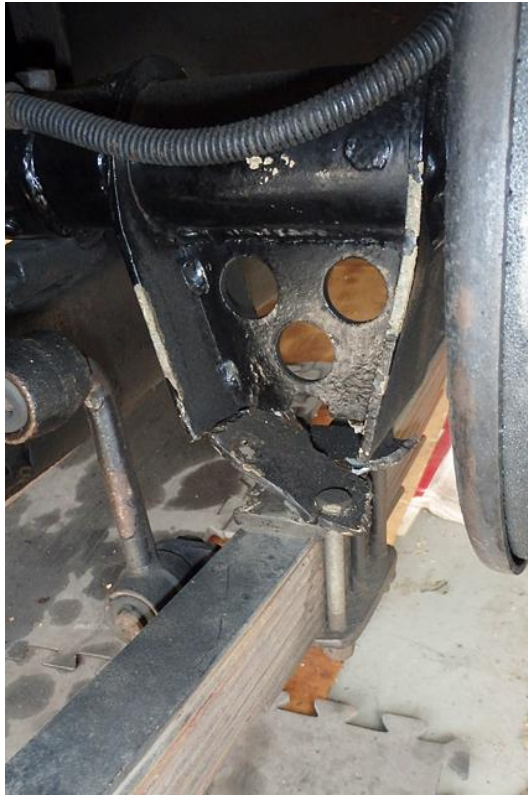
Several TCMG members have reported tower failures in the past decade. The title photo of this article is Pete and Fran Thelander's car which failed at speed in 2016. Two others failed in the following 12 months.

If your axle has suffered a total failure like the one in the title photo then you're beyond the point of a simple gusset. The lower plate will need to be completely replaced. Here we see a further modification by Pete Thelander where not only was the lower plate replaced with new metal, but it was also extended to reduce the strain on the very thin metal between the bolt holes and edges.

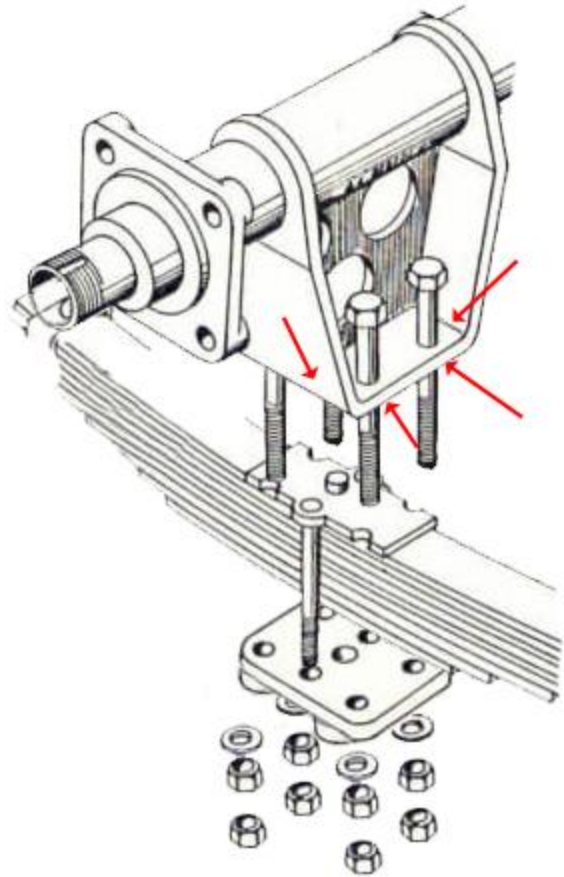
All areas of the tower should be inspected, but our primary area of focus is the bottom plate. Areas of greatest concern are along the sections where the bottom curves up to the sides, which may show evidence of stress or surface cracking, and the bolt holes which usually crack between the hole itself and the closest edge. Loose mounting bolts can exaggerate these cracks because once the spring / tower union is loose, twisting forces are concentrated around the bolt heads instead of being spread out over a larger area. Make the tower and mounting bolts part of your annual safety inspection!

Red arrows are marking areas of greatest stress.

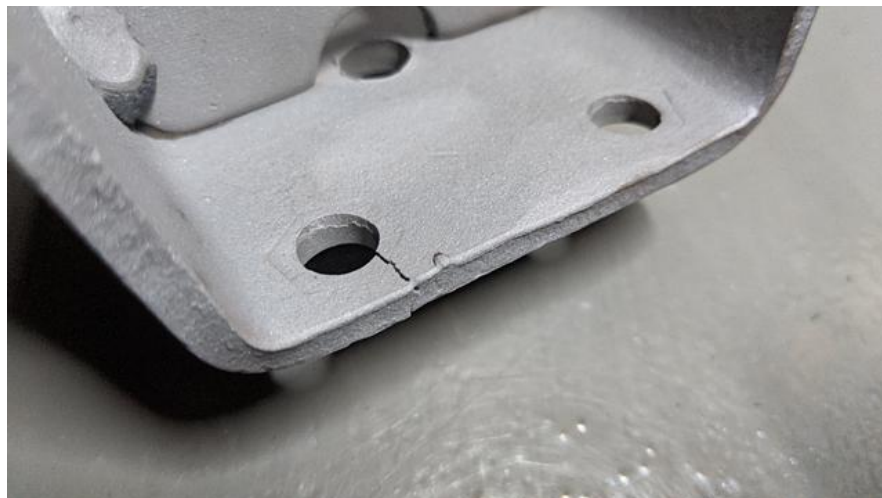
To begin inspection, clean all grease, oil and road grime from the area to aid in spotting issues. It is not uncommon for cracks to be hidden by paint as well. The accompanying image below shows one of six cracked bolt holes found on TC9849/EXU that was not visible until a thick layer of paint was removed.

Cracked tower bolt hole. Note how the metal has separated.

Once all trouble spots have been identified, it's time to get out the welding gear. Axle towers with minor cracks can be welded and returned to service. If there is evidence of additional fatigue along the edges of the bottom plate then the tower should be deemed unsafe and undergo further repair and reinforcement as outlined in the next section.

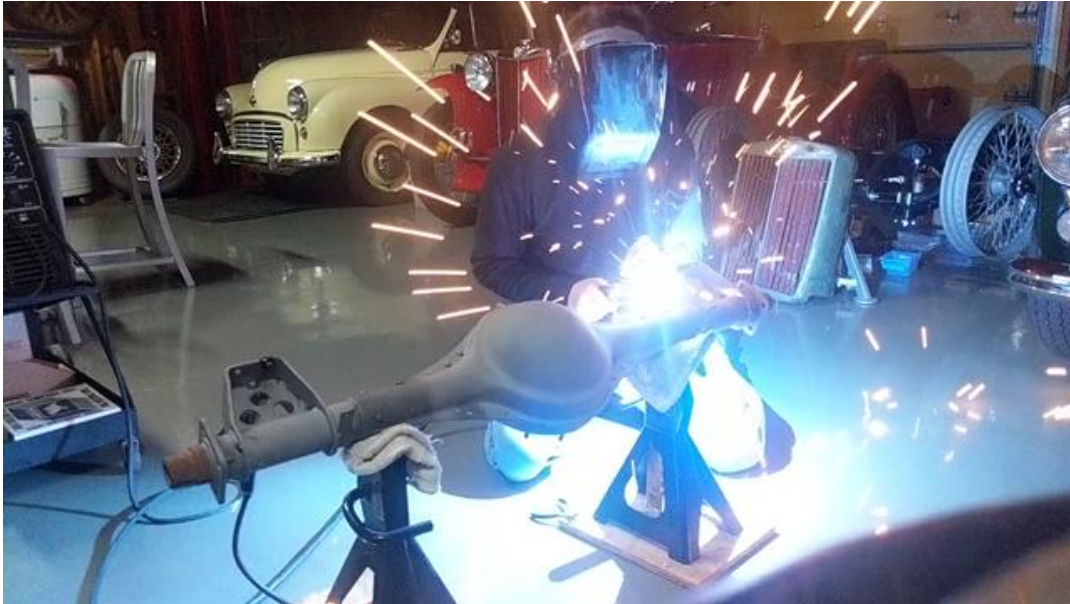
Welding cracked bolt holes. Keep a fire extinguisher handy.

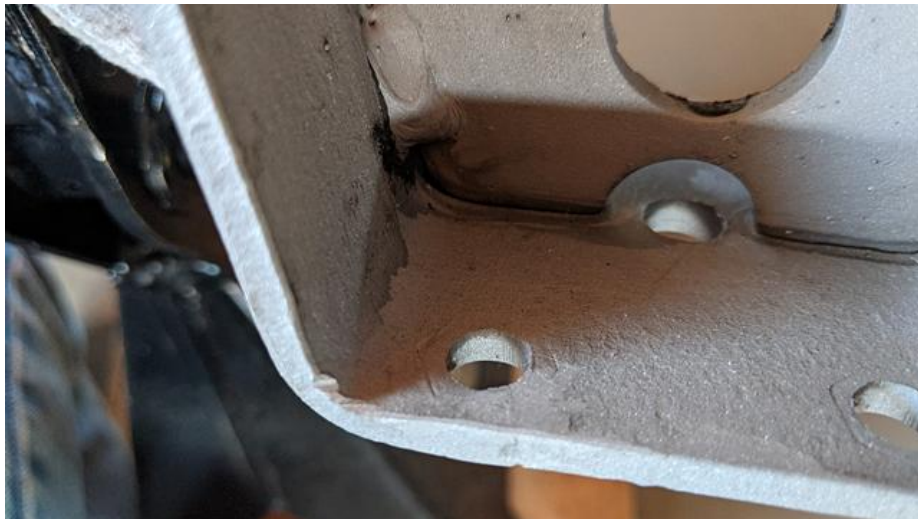
The above bolt hole, repaired.

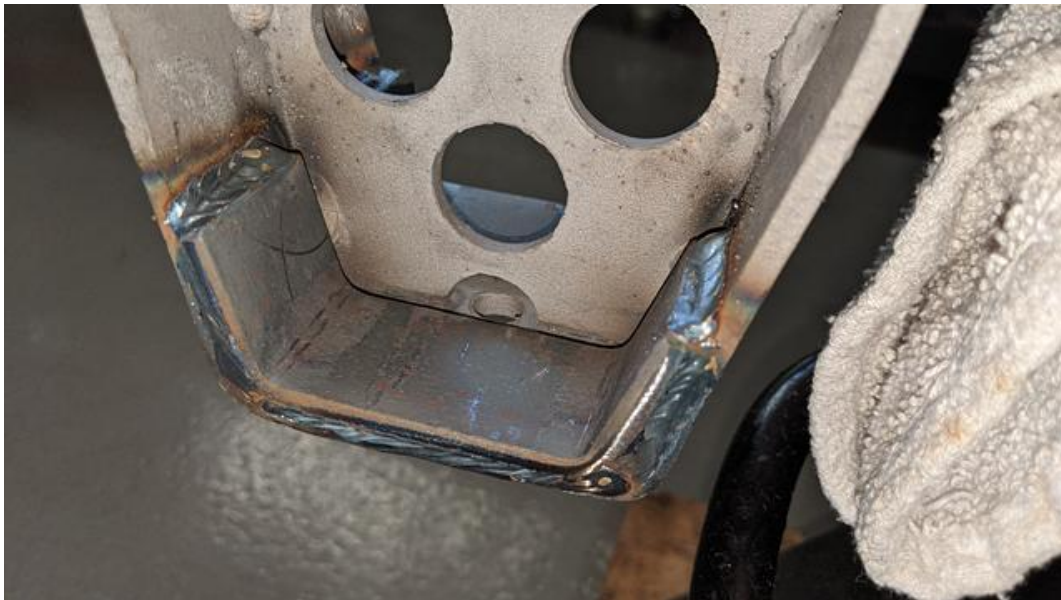
One of four gussets welded in place.

The first step is to thoroughly clean the area to ensure a good surface to weld on. With all existing cracks repaired, a steel gusset is formed to fit snugly into the bottom of the tower. The exact size of the gusset is probably not important, but it should extend well above the highest stress areas near the bottom plate. One gusset is installed on each side of each tower, so four gussets in total.

A professional welder can do this job in a day at nominal cost. The above photo shows one of four gussets fabricated and installed at a shop near the author for \$160 USD. Bring photos to show them exactly what needs to be done.

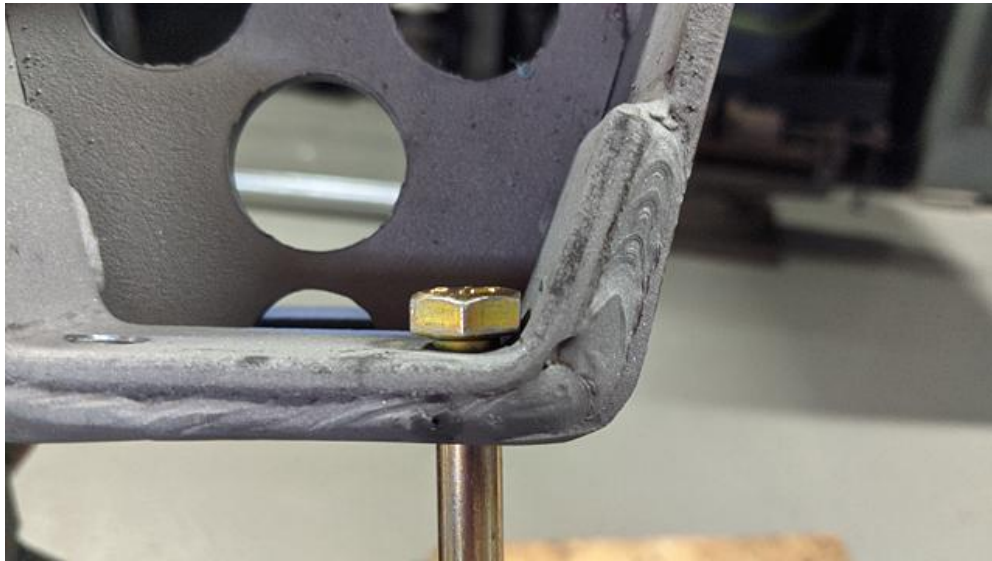
Here we see what happens when one of the gussets was a little short. The slight gap is not a problem for the strength of the gusset, but it presents a problem when you put the bolts in.

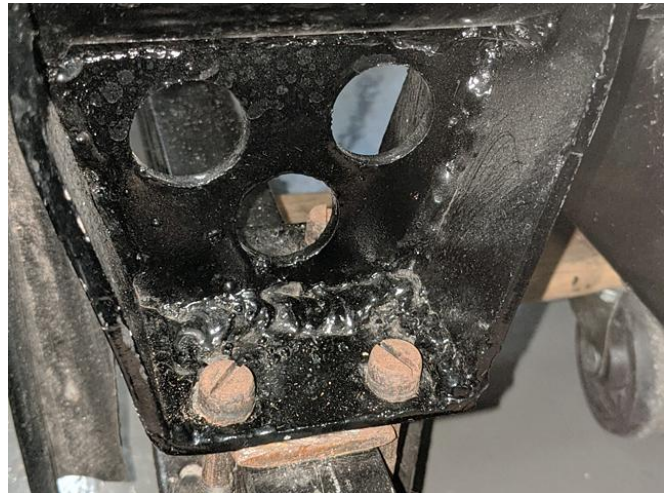
The next image shows a previous owner's very poor attempt at re-attaching a broken lower plate on Linda Simmons' TC7018, using welds that resemble Elmer's glue.

When replacing the bottom plate, it is VERY IMPORTANT to ensure that the towers are exactly the same height and sitting perfectly level to each other, or the car will not sit level and the springs may be subjected to additional stress. It is probably not necessary to cut and replace the opposite side unless there is evidence of impending failure, but reinforcing gussets would be a good idea.
