XPAG Chevy Rear Seal Conversion

Notes on a Successful 4th Attempt

by David Edgar, TC 5108

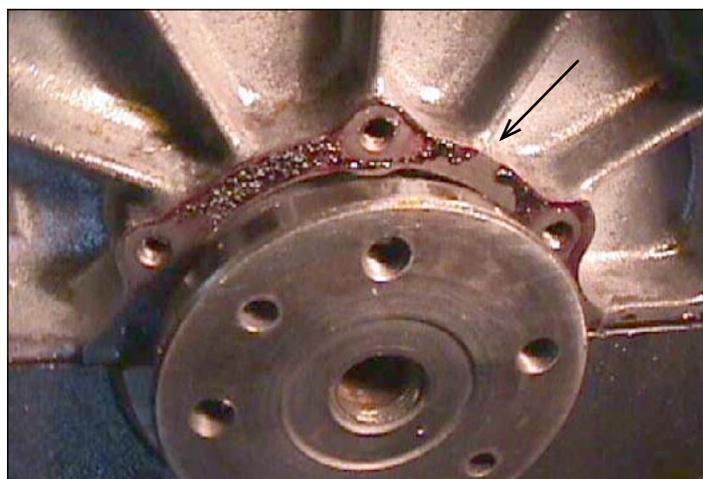
This shows my second crank with the short journal. Front lip of regular seal does not ride on the journal. Buying an off-set seal solved the problem as shown in the lower half of the picture.

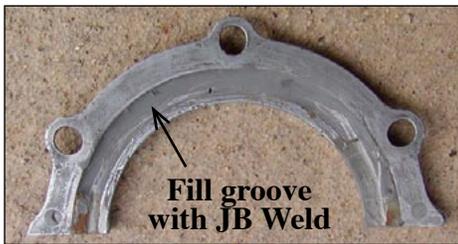
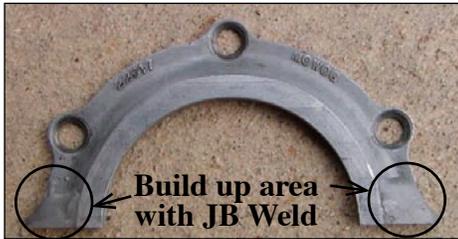
Note gap where oil could leak past when warped cover and not enough RTV was used.

opted to use countersunk allen head screws which pretty much locked the plate into position. I was told by others to both remove the two dowel locating pins as well as to ovalize the bolt holes. Doing this would allow you to push the cover down tight against the bearing cap to ensure a tight seal. Since I had the countersunk screws locating the cover, I added JB Weld to the bottom edge, Bolted cover and bearing cap to the engine briefly and then removed the cover. Once set, the JB Weld took up any gap that there may have been.

Lastly, no need for a paper gasket behind the cover. Just use RTV.

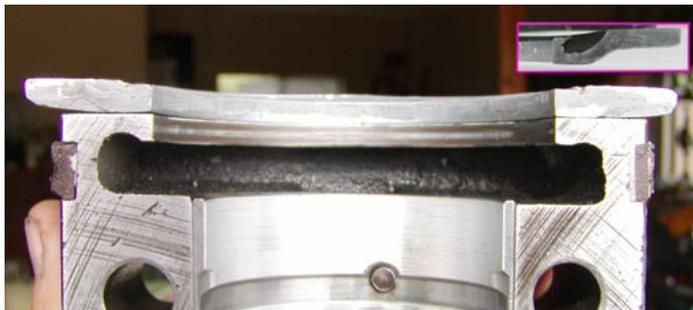
Lower edge on front also built up

Another view of the aluminum cover showing bottom edge after filling in front and back with JB Weld. Inset shows surface area before filling in. Wider surface would butt up against the bearing cap (not in this position though).

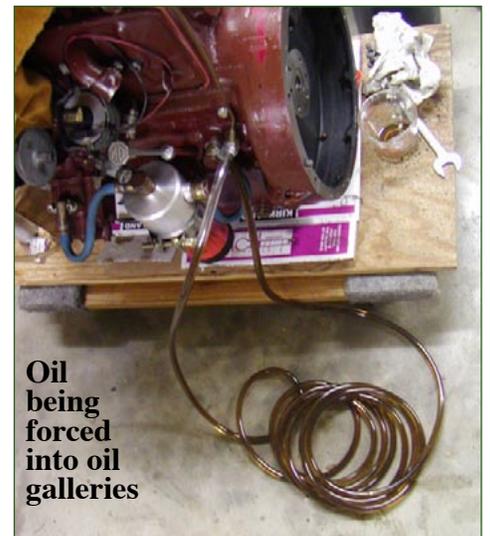
Oil being forced into oil galleries
