TC Rear Axle Tower Repair

(And how to keep it from failing in the first place)

Steve Simmons
TC Motoring Guild
May, 2021

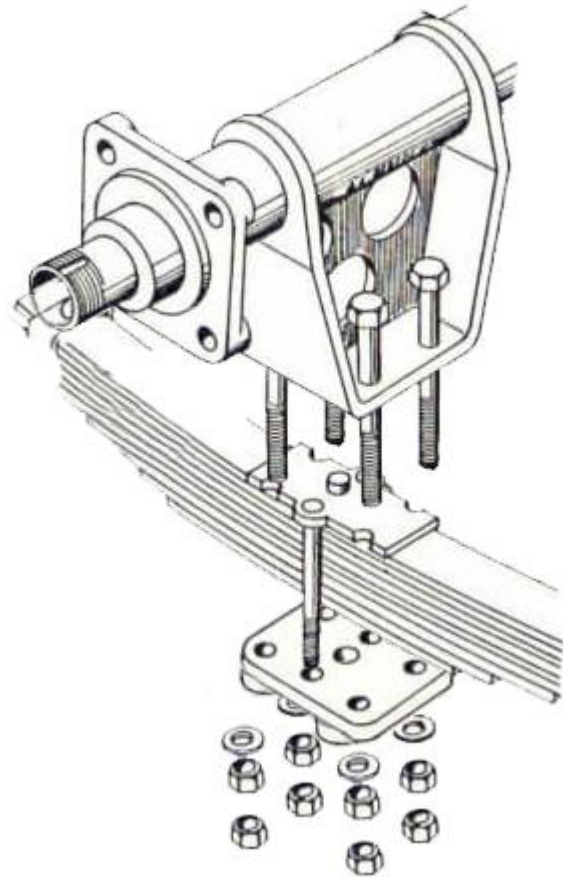
TC Rear Axle Tower Assembly

All areas of the tower should be inspected, but our primary area of focus is the bottom plate. Areas of greatest concern are along the sections where the bottom curves up to the sides, which may show evidence of stress or surface cracking, and the bolt holes which usually crack between the hole itself and the closest edge. Loose mounting bolts can exaggerate these cracks because once the spring / tower union is loose, twisting forces are concentrated around the bolt heads instead of being spread out over a larger area. Make the tower and mounting bolts part of your annual safety inspection!

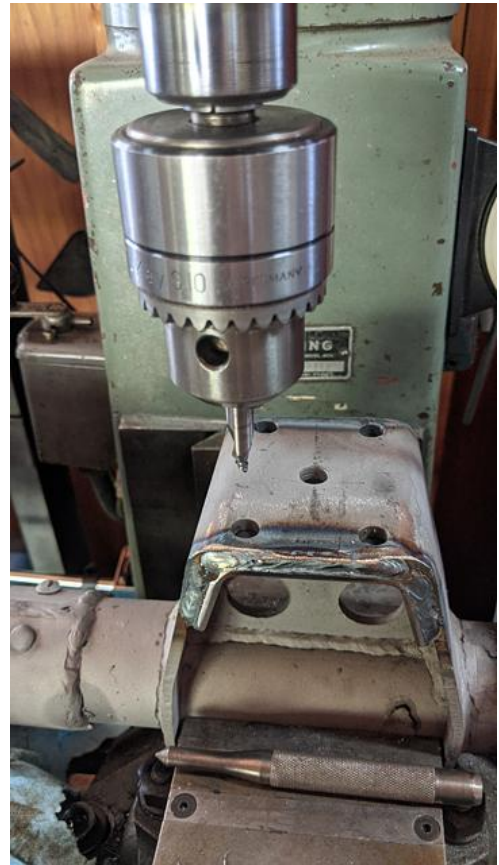
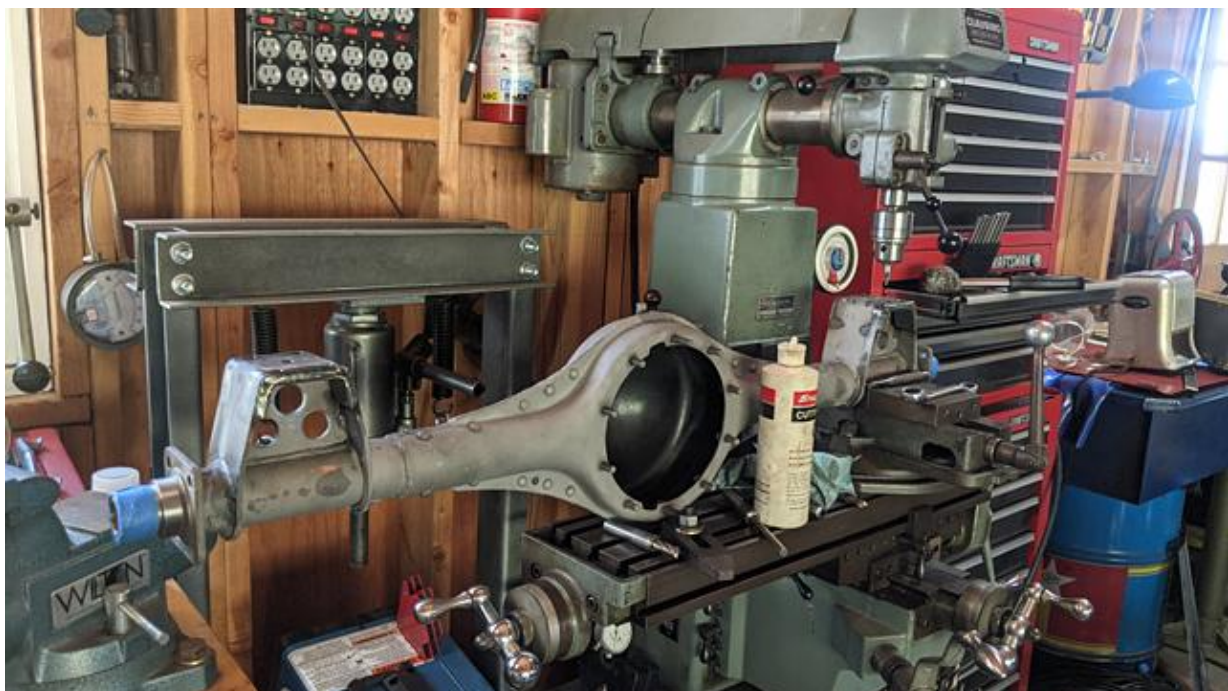
Here we see what happens when one of the gussets was a little short. The slight gap is not a problem for the strength of the gusset, but it presents a problem when you put the bolts in.

Below is after careful grinding to give the bolt head clearance. The surface should be as flat as possible to give the bolt head even support. If you feel you ground it a little too far, you can possibly use a D washer under the head.

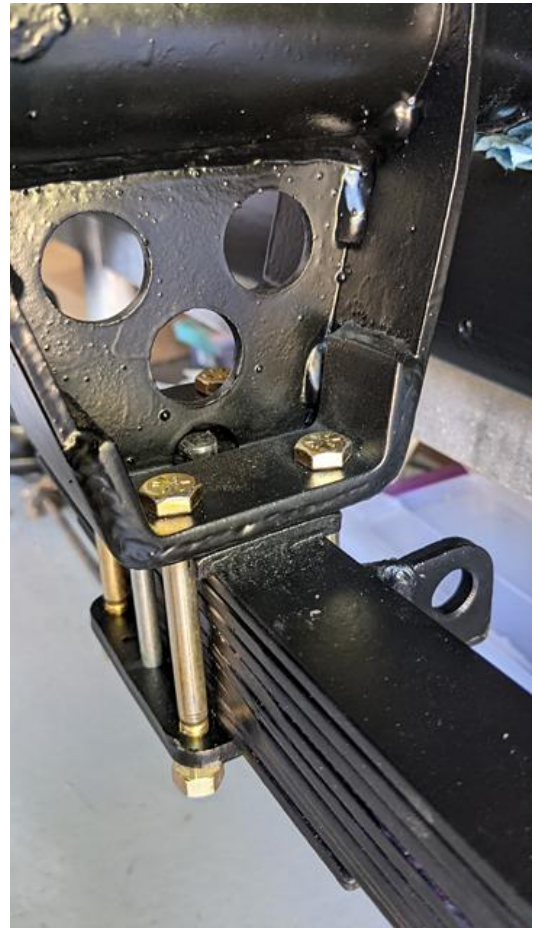
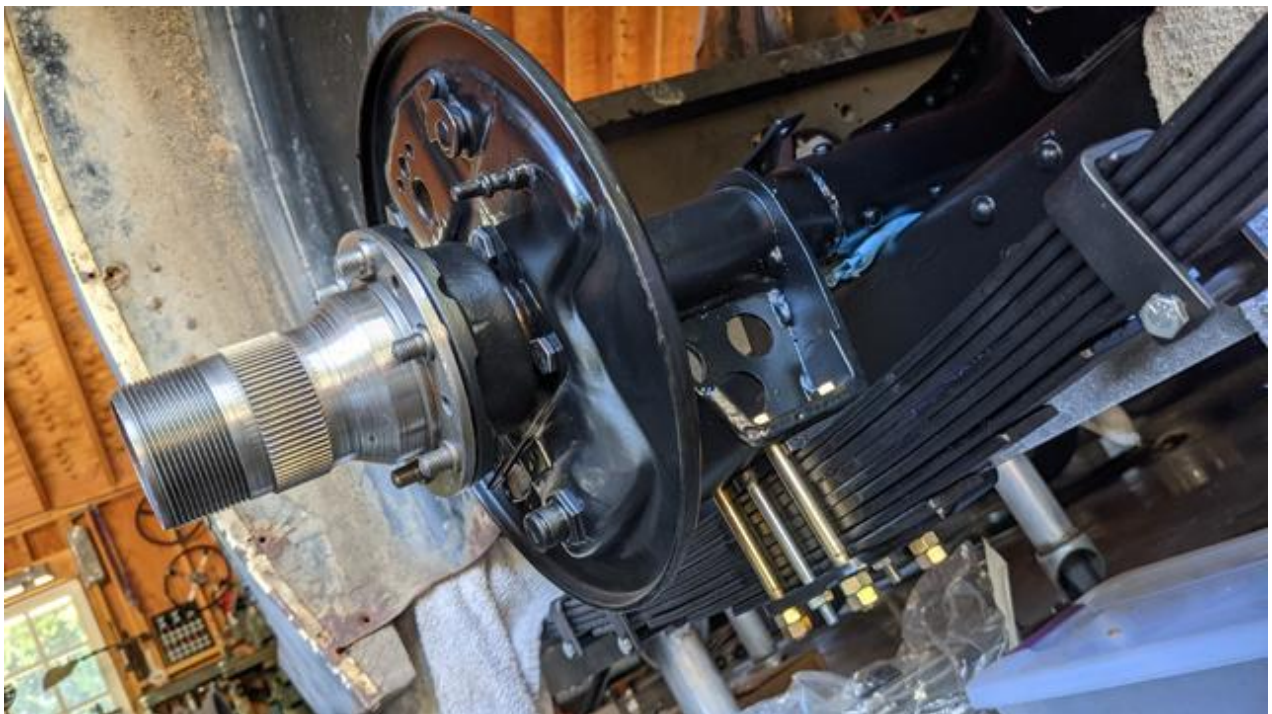
With everything back together, you should now have a rear axle assembly that will never leave the car on its own accord!

After painting with something durable, it's time to mount the axle back onto the springs. Original style hardware is available from several sources, but you will need to source longer than standard bolts. For those who aren't concerned about strict originality, you can purchase high-strength hardware from your manufacturer of choice.

The author is mistrusting of today's corner hardware store offerings, having far too easily broken bolts that are supposed to be of a particular grade, so an order from a reputable supplier was made. Bolt sizes are 5/16"-24 x 3.5" in length. Double nut the bottom with jam nuts of equal strength.
